GROUP <b>Product Improvement</b>	MODEL <b>See Model List on Page 1</b>
	NUMBER <b>PI1802W/X (Rev 2, 01/28/2018)</b>	DATE <b>October 2018</b>
<b>PRODUCT IMPROVEMENT CAMPAIGN</b>		
SUBJECT: <b>ENGINE REPLACEMENT INSTRUCTIONS FOR DTC P1326 (PI1802W/X)</b>

This bulletin provides information related to the Technical Service Bulletin previously published in July 2018 ([PI1802](#), Rev 5, 12/20/2018) titled “Knock Sensor Detection System - ECU Logic Improvement”. Specifically, this bulletin provides instructions on which procedures to follow if, after installation of the KSDS, any one of the subject vehicles below returns to the dealer with Diagnostic Trouble Code (“DTC”), P1326.

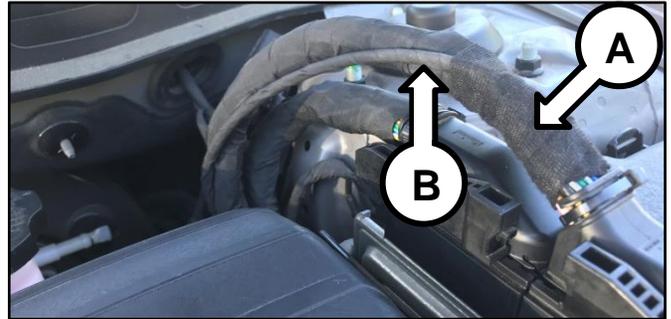
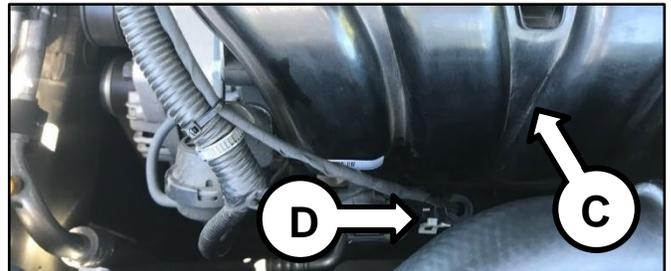
**NOTE:** To identify the extension harness (B), look for an external harness (B) which should be cable-tied to the existing wiring harness (A) leading by the intake manifold (C) to the knock sensor (D), as shown.

- If the extension harness (B) has been installed, open a Techline case online.
- If the extension harness (B) has not been installed, proceed to the next step.
